# Testing for Stray Current Corrosion in Earth Covered Magazines with EOP

**O. S. Marshall**

US Army Engineer Research and  
Development Center, Champaign, IL

**J. E. Bennett**

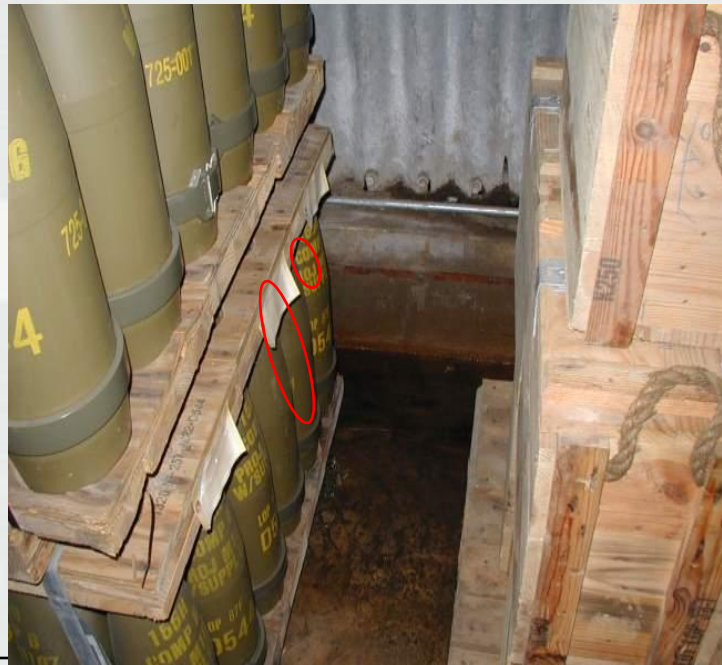
- The water intrusion causes corrosion
  - ▶ Structural steel
  - ▶ Stored assets making many unusable
  - ▶ Mold and poor air quality

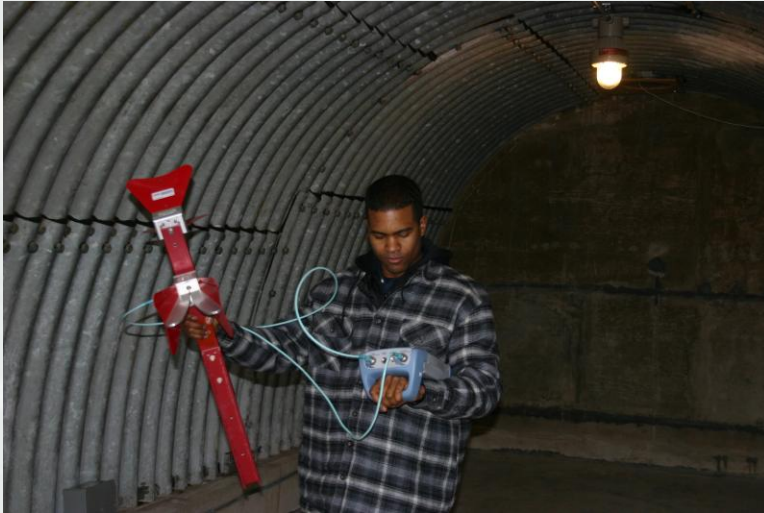
RF Emission Testing

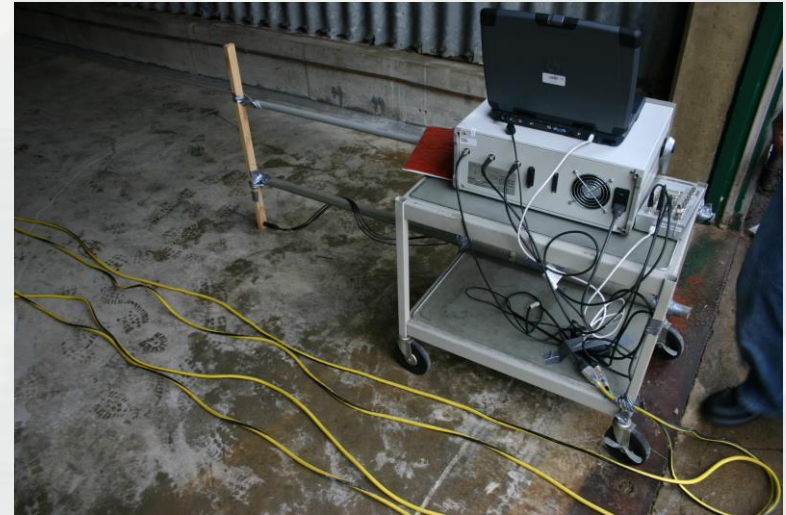
EM Emission Testing
